Ames Research Center Shear Tests of SLA-561V Heat Shield Material for Mars-Pathfinder

September 1996

This report describes the results of arc-jet testing at Ames Research Center on behalf of Jet Propulsion Laboratory (JPL) for the development of the Mars-Pathfinder heat shield. The current test series evaluated the performance of the ablating SLA-561V heat shield material under shear conditions. In addition, the effectiveness of several methods of repairing damage to the heat shield were evaluated. A total of 26 tests were performed in March 1994 in the 2" × 9" arc-heated Turbulent Duct Facility, including runs to calibrate the facility to obtain the desired shear stress conditions. A total of eleven models were tested. Three different conditions of shear and heating were used. The non-ablating surface shear stresses and the corresponding, approximate, non-ablating surface heating rates were as follows: Condition I, 170 N/m² and 22 W/cm²; Condition II, 240 N/m² and 40 W/cm²; Condition III, 390 N/m² and 51 W/cm². The peak shear stress encountered in flight is represented approximately by Condition I; however, the heating rate was much less than the peak flight value. The peak heat

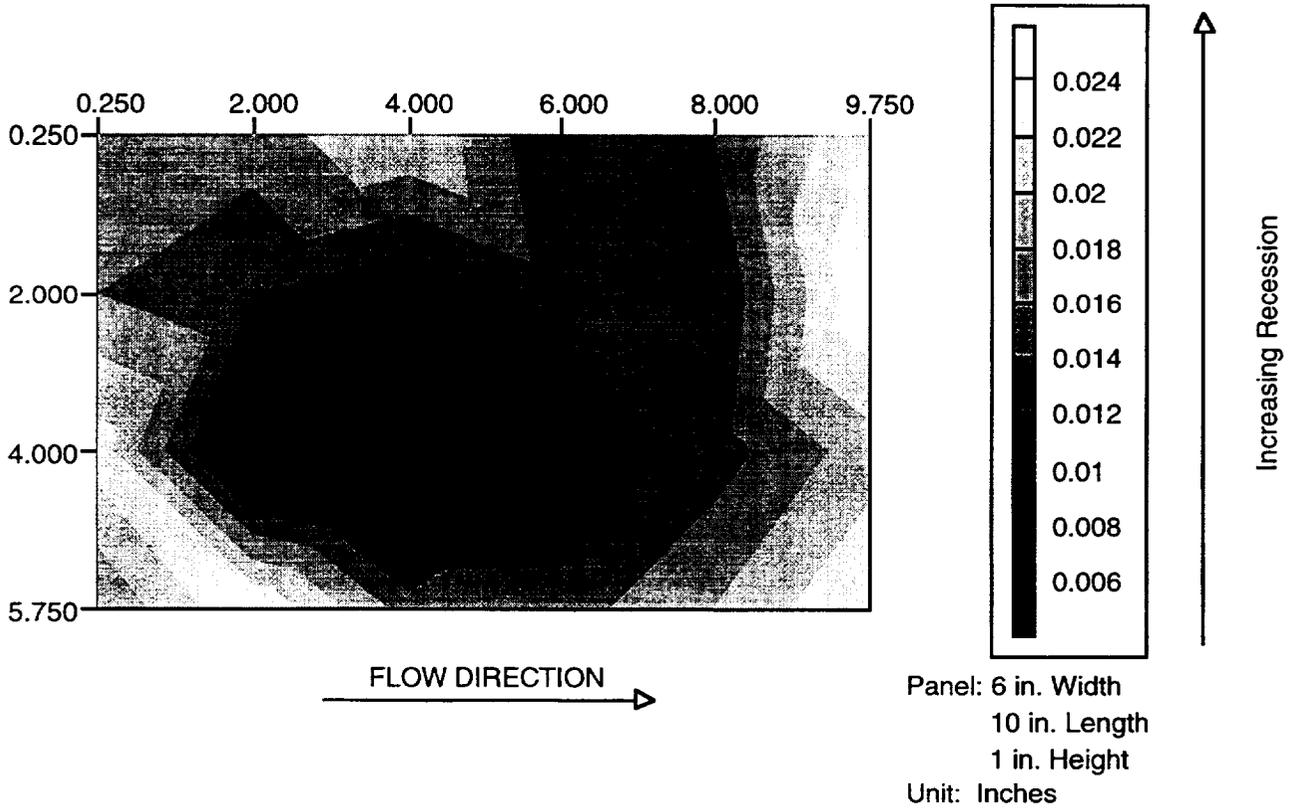
RECESSION CONTOUR PLOT
MODEL ID: SLAP06TC-2

Figure A-25. Recession contour plots of model SLAP06TC-2.

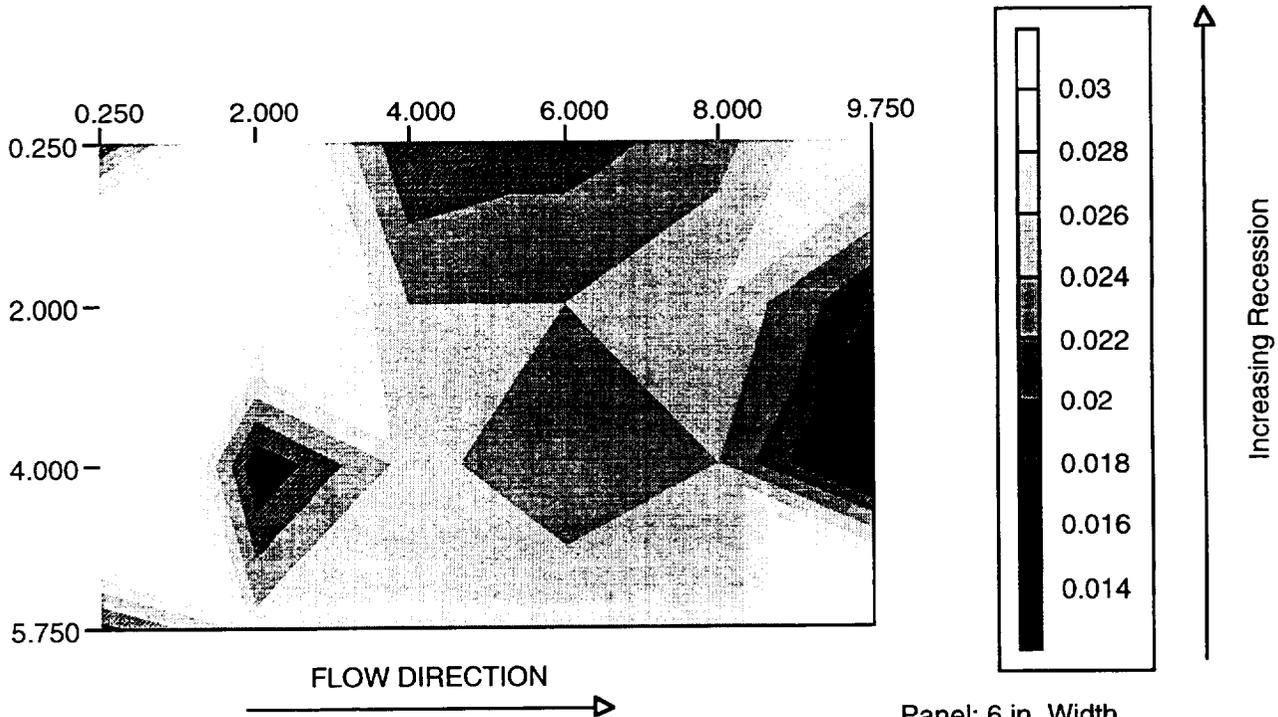
RECESSION CONTOUR PLOT
MODEL ID: SLAP07TC-3

Figure A-26. Recession contour plots of model SLAP07TC-3.

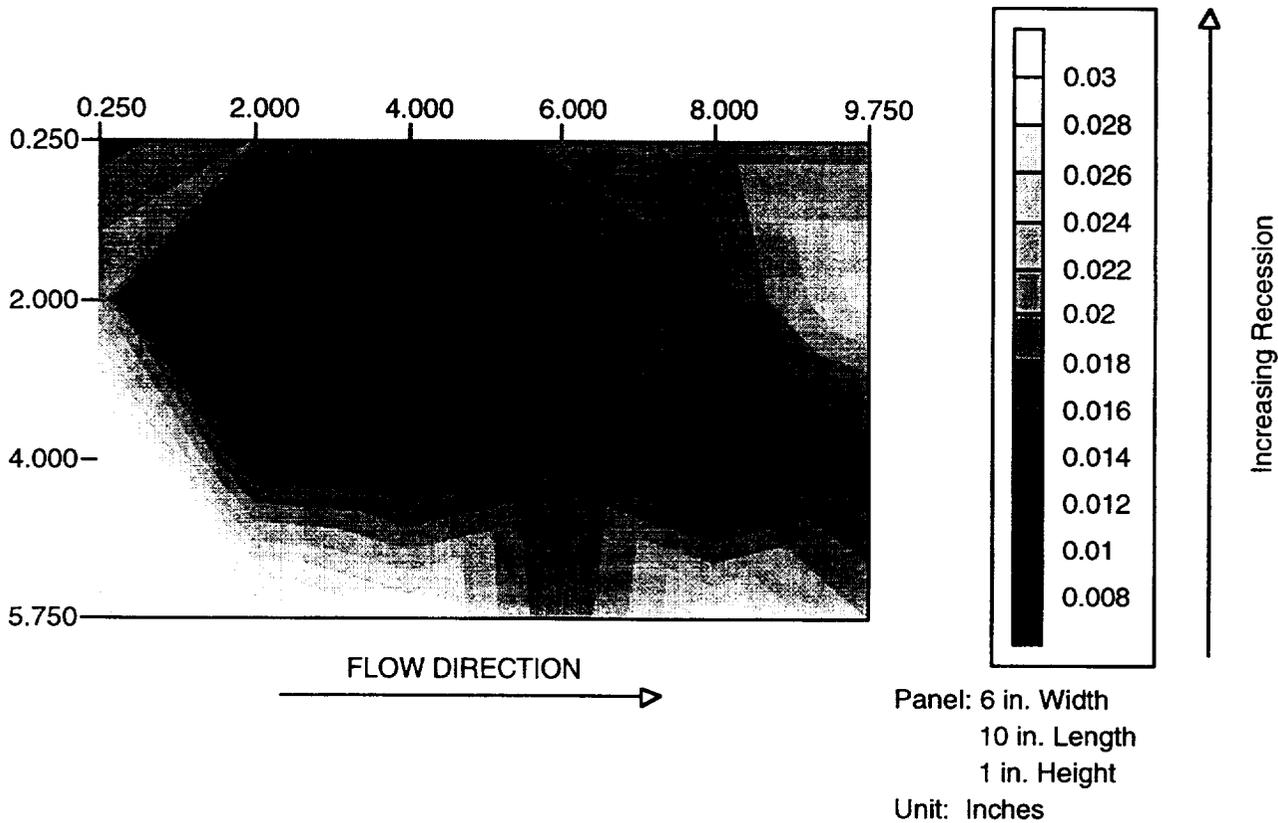
RECESSION CONTOUR PLOT
MODEL ID: SLAP08R-3

Figure A-27. Recession contour plots of model SLAP08R-3.

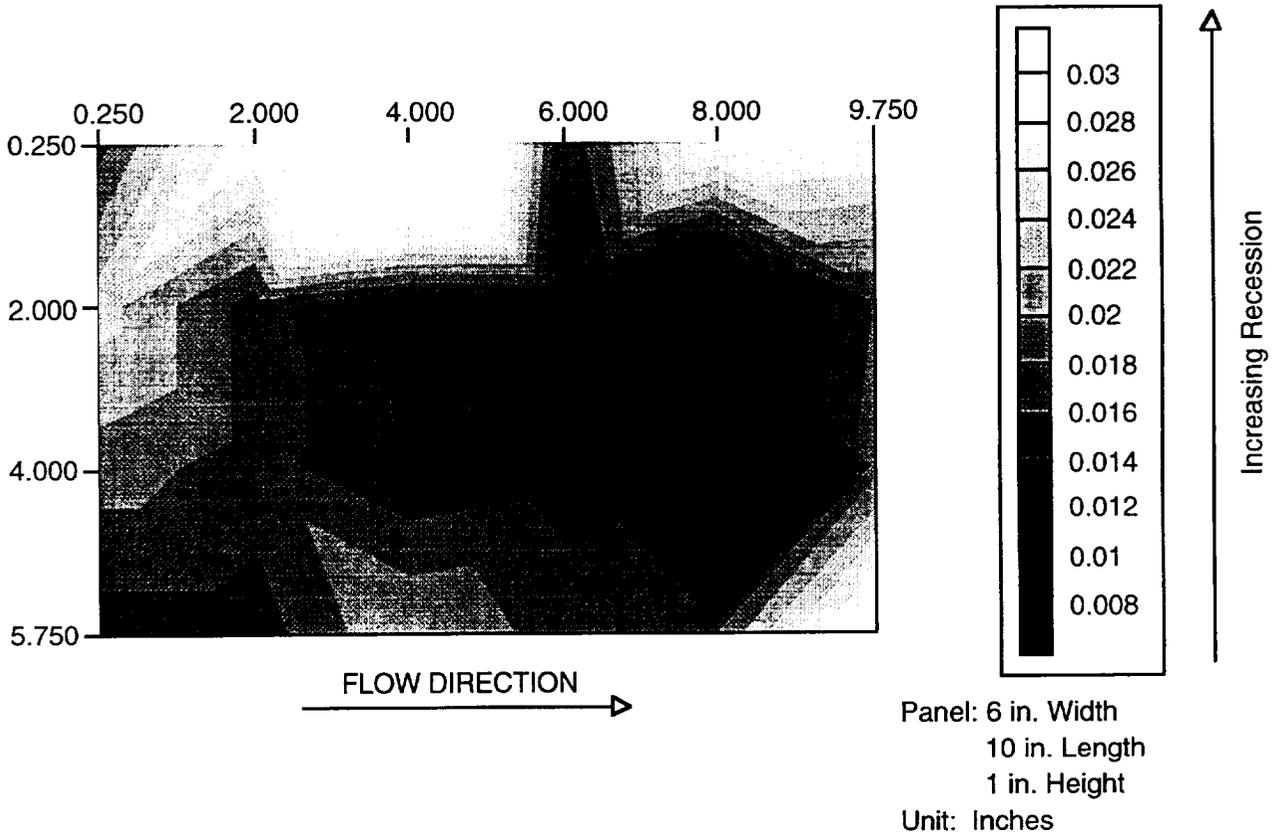
RECESSION CONTOUR PLOT/
MODEL ID: SLAP09R-3

Figure A-28. Recession contour plots of model SLAP09R-3.

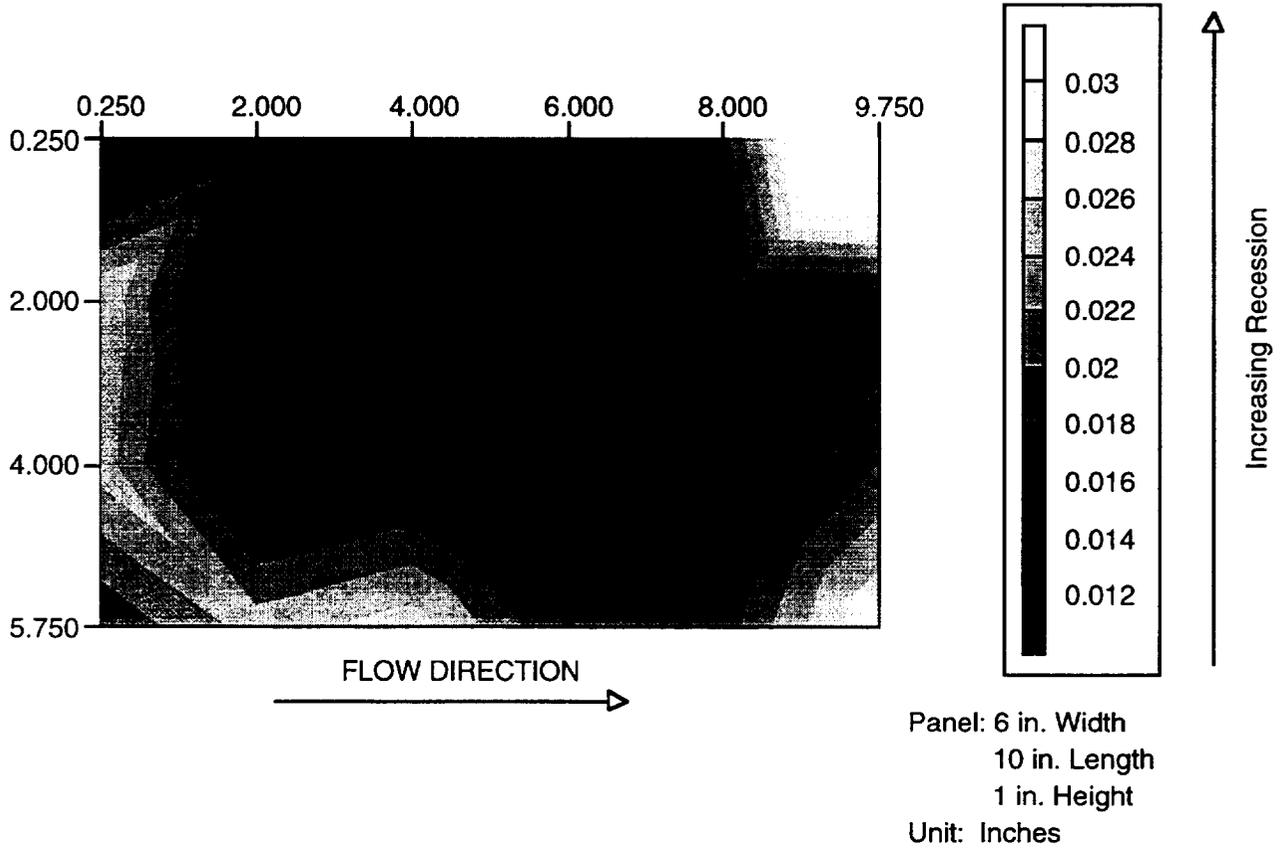
RECESSION CONTOUR PLOT
MODEL ID: SLAP010R-3

Figure A-29. Recession contour plots of model SLAP010R-3.

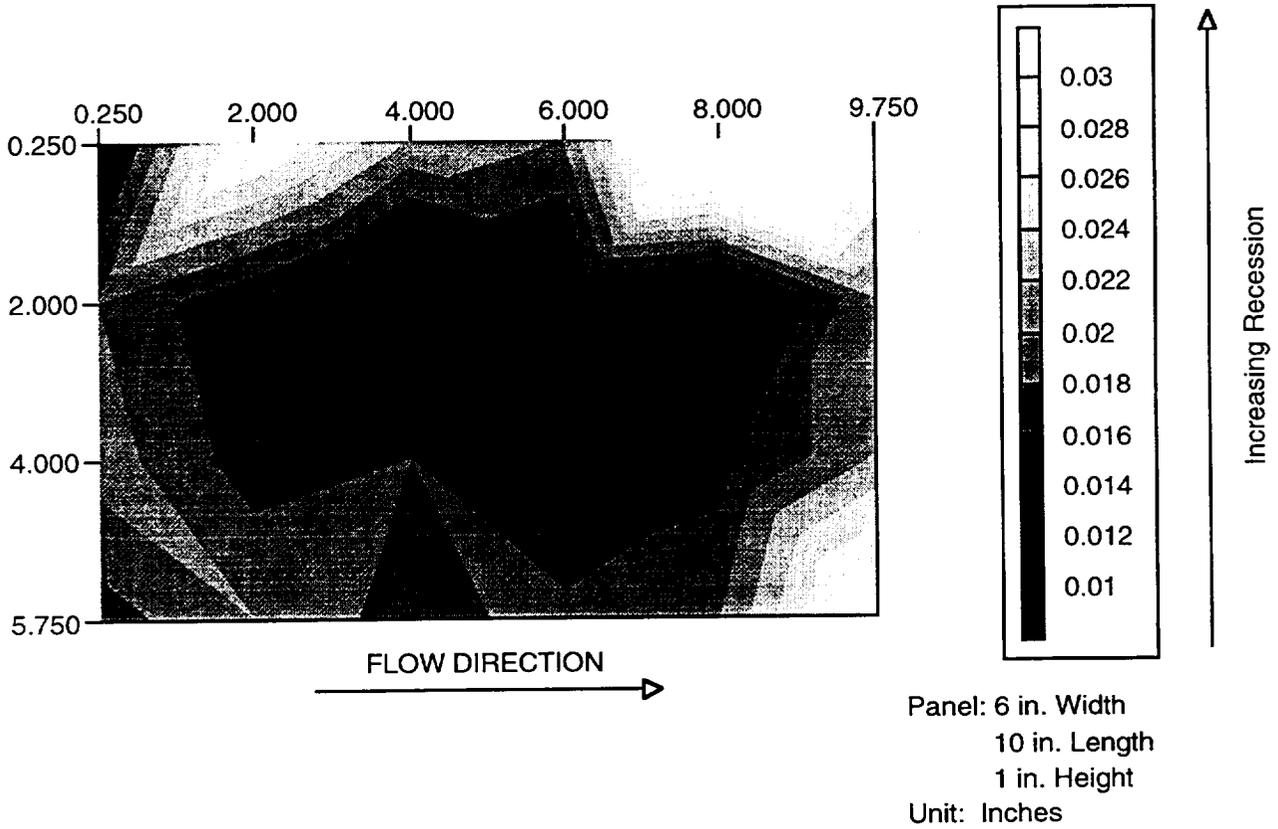
RECESSION CONTOUR PLOT
MODEL ID: SLAP011R-3

Figure A-30. Recession contour plots of model SLAP11R-3.
